# ANNUAL REPORT FOR 2016

**Harris Mill Run Creek**  
**Pitt County**  
**TIP No. U-5018A**  
**USACE Action ID: 200900960**  
**DWR Project #: 20090261 v.1**

Prepared By:  
Roadside Environmental Unit & Natural Environment Section  
North Carolina Department of Transportation  
August 2016

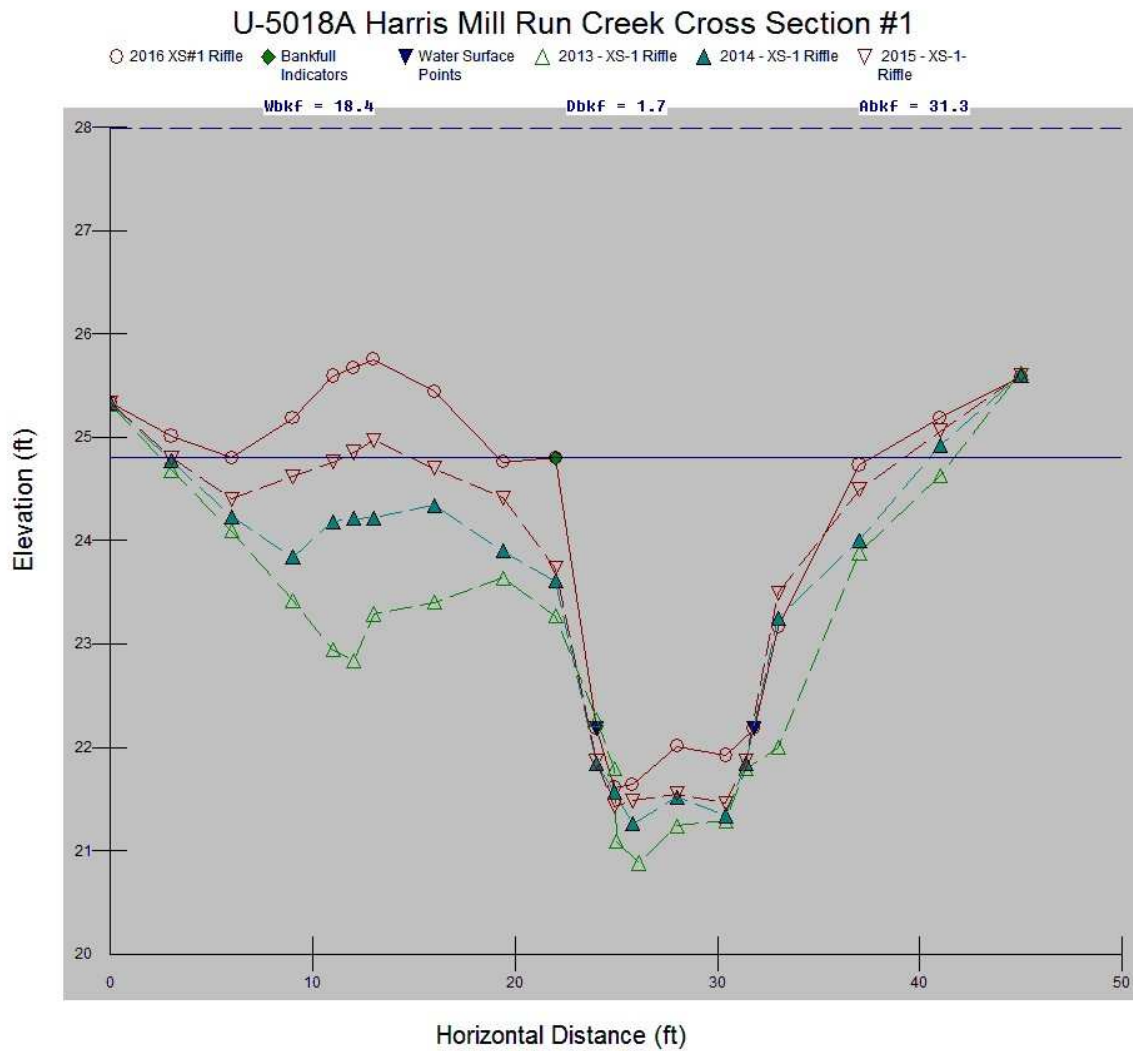
Based on the 2016 monitoring data, the one riffle cross section appears stable with little or no active bank erosion. The cross section shows a large deposit of sand along the left bank due to numerous bankfull events. The graphical representation of the cross section is presented in Appendix A. Future survey data will vary depending on actual location of rod placement and alignment; however this information should remain similar in appearance. Through visual observation, the channel appears stable throughout the mitigation site at this time.

Cross-Section #1 (Riffle) Abbreviated Morphological Summary					
	2013	2014	2015	2016	2017
Bankfull Width (ft)	17.09	17.88	17.49	18.41	
Bankfull Mean Depth (ft)	1.47	1.34	1.71	1.7	
Width/Depth Ratio	11.63	13.34	10.23	10.83	
Bankfull Cross Sectional Area (ft <sup>2</sup> )	25.17	24.02	29.82	31.34	
Maximum Bankfull Depth (ft)	2.76	2.64	2.98	3.19	
Width of the Floodprone Area (ft)	45	45	45	45	
Entrenchment Ratio	2.63	2.52	2.57	2.44

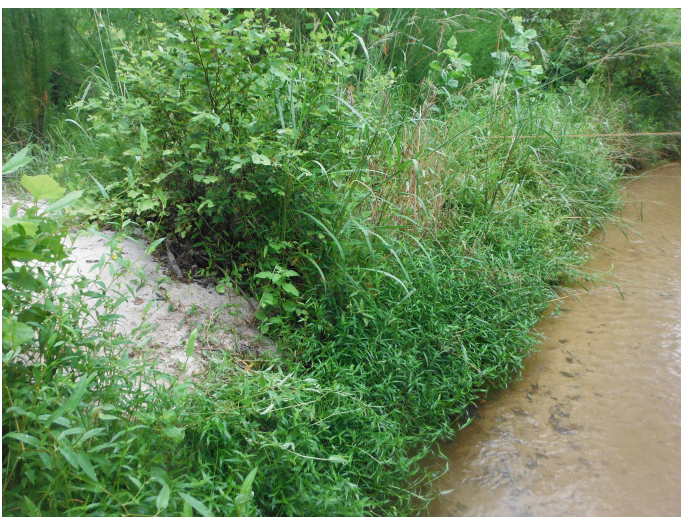
Wrack line noted along left bank  
August 2016

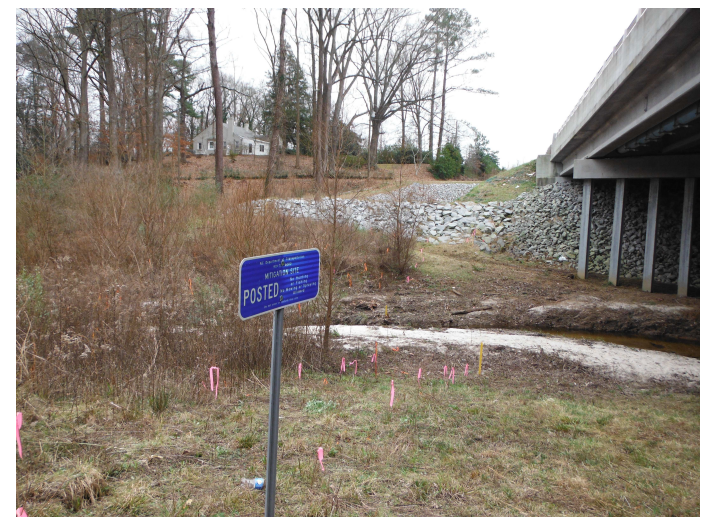
**Site Notes:** A small area within the site along the bridge was mowed by contractors in January 2016 and immediately replanted by NCDOT. Other vegetation noted onsite included sweetgum, soft rush, *Sagittaria* sp., fennel, lespedeza, goldenrod, baccharis, kudzu, cattail, pine, and various grasses. Small pockets of kudzu were encroaching into the planted area from the Northeast side of the site. NCDOT will continue to spray the kudzu throughout the monitoring period as needed. The kudzu was not affecting the overall performance of the planted trees at this time.

Mowed area that was replanted in January 2016

Based on the overall conclusions of monitoring along Harris Mill Run Creek, the site has met the required monitoring protocols for the fourth formal year of monitoring. Based on the fourth year of monitoring data, the channel is stable throughout the stream at this time. The streambank and buffer are meeting planted vegetation success criteria for the fourth year of monitoring. A small area within the site along the bridge was mowed by contractors in January 2016. The mowed area was replanted in January 2016 following the reported encroachment. See Appendix B for photos of the replanted area.
